LIGHTHOUSE

A Monthly Technical Magazine

OCTOBER - 2020

LESSONS LEARNED FROM SCRUBBER INSTALLATION AND OPERATION

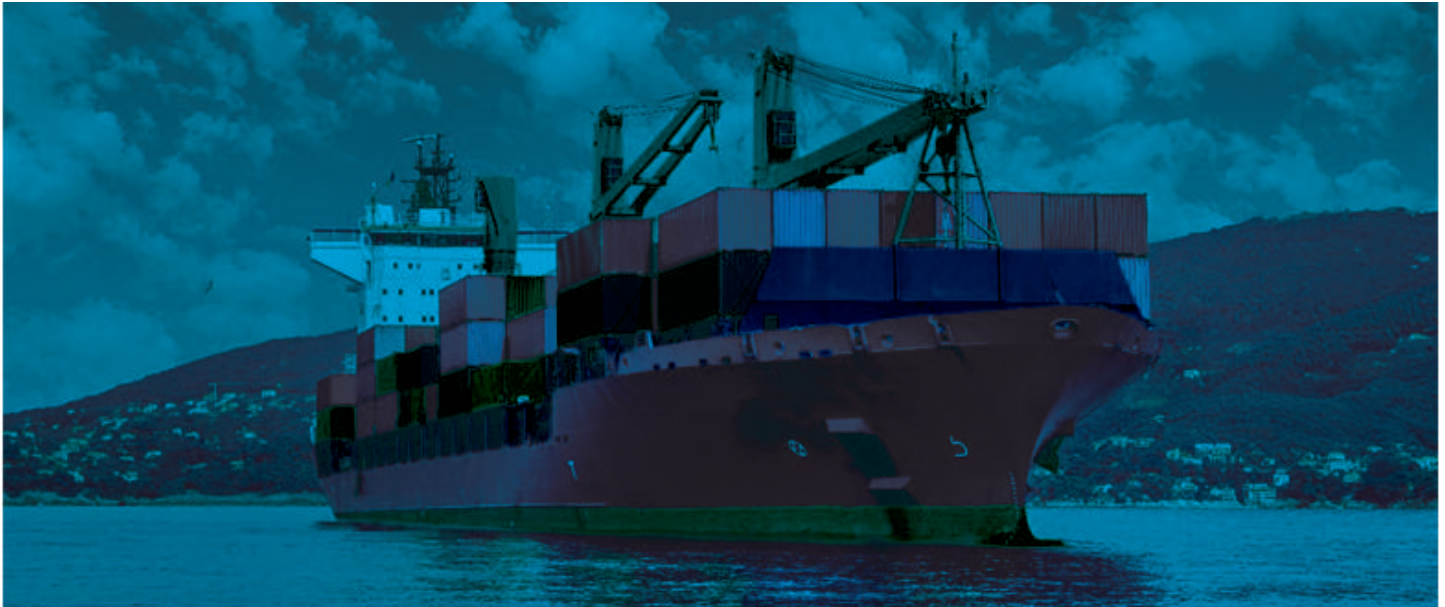
HARDWARE FAILURE

When a SO_x Scrubber system suffers a hardware failure there can be multiple causes. Below are some that industry-operating history suggests owner/operators may want to consider investigating when searching for solutions:

- The sampling tubing may have become clogged, preventing accurate readings of SO₂/CO₂ ratios in the exhaust gas
- The pressure transducers at the bottom of the pipe run may have become clogged with debris because the sensors were located in the wrong places
- The demister in the scrubber chamber may have malfunctioned due to a build-up of deposits
- Defective welds on piping system could have allowed washwater to leak
- Low-grade stainless steel (e.g. SS316 for fittings inside the scrubber chamber) may not have held up to the corrosive operating environment

- The metallic pipe section on the side shell used to discharge washwater also may be corroded
- The air pump that samples exhaust gases may not be working properly
- The scrubber's uptake damper cannot be operated in manual mode
- The mechanical seals for the washwater feed pumps may have failed
- The automation controls for printed circuit boards may have failed
